Double Pass Electro-Deionization

IWC-11-063

ABSTRACT: This paper will review the lessons learned in designing, commissioning and operating a water treatment system consisting of second pass reverse osmosis system, complete with an antiscalant feed, sodium bisulfite feed system and cartridge filters as pretreatment; followed by a membrane degasifying system, primary polishing electro-deionization; followed by a second pass polishing electro-deionization system for a combined cycle co-generation power plant. This paper shall provide background on equipment selection, unit operation, water quality issues, system rework, operational problems, system profiling and validation protocol.

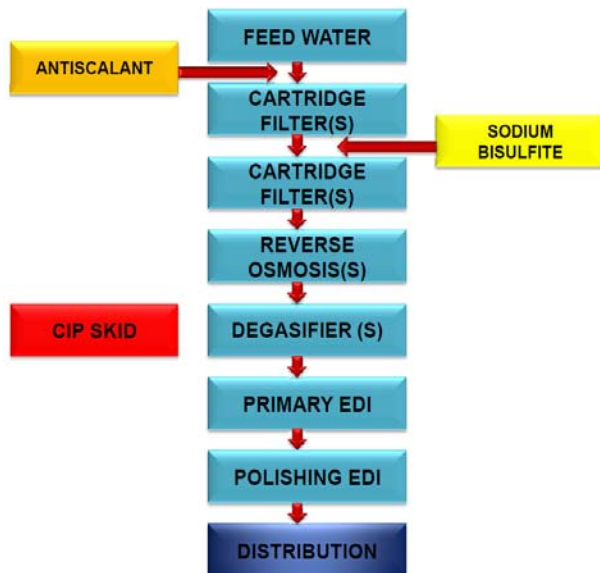
FIGURE 1–WATER TREATMENT SYSTEM

The Make-up Water Treatment System (MWTS) illustrated in Table 1 consists of two-(2) 100% trains indentified as A & B rated at 50 gpm of permeate each. The system consists of one-(1) Antiscalant Feed System (AFS), one-(1) Sodium Bisulfite System (SBS) four-(4) Cartridge Filters, two-(2) Reverse Osmosis Systems (ROS), two-(2) Membrane Decarbonator Systems (MDS), two-(2) Electro-deionization (EDI), one-(1) Clean-In-Place (CIP) System and one-(1) Waste Neutralization System (WNS). Other ancillary equipment was provided as required to make this system a complete and workable system.

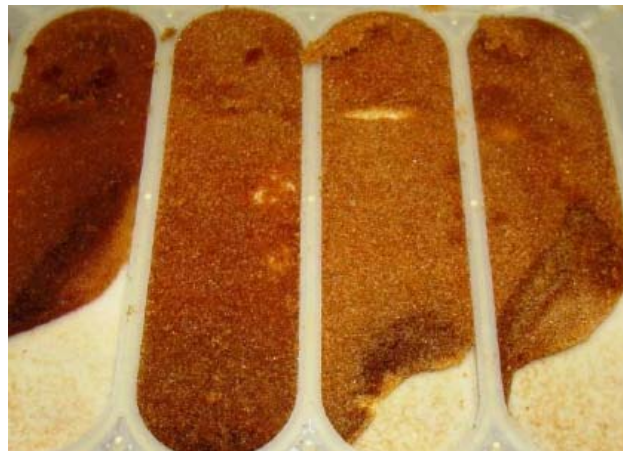
FIGURE 4 – RESIN SLUMPING

It was determined the primary cause of high electrical resistance was due to high pressure fluctuations (water hammer).

This was based on the collapse of the concentrate support resin.

The slumping of resin illustrated in Figure 4 in most of the concentration cells indicated two-(2) possibilities:

- Pressure imbalance/spikes during operation
- Module was under filled when built

Normally, the resin in all chambers is consistent and completely filled. This allows consistent path for electrical current to flow across the EDI module as highlighted in the resin filled concentrate chamber patent. With this module, it is clear the degradation of resin structure increased the electrical resistance.

In reviewing the as-built test data, pressure drops were within the normal range indicating that the modules were not under filled. It appears more likely that this module operated with some pressure imbalances or hydraulic shock that resulted in slumping in the concentrate. This condition would cause an increase in the module resistivity and thus affect water quality.

Pressure spikes can also be caused by abrupt starting or stopping the ROS. The system operation should be reviewed for possible causes of water hammer (such as rapid opening and/or closing of valves) and of product/reject pressure imbalance.

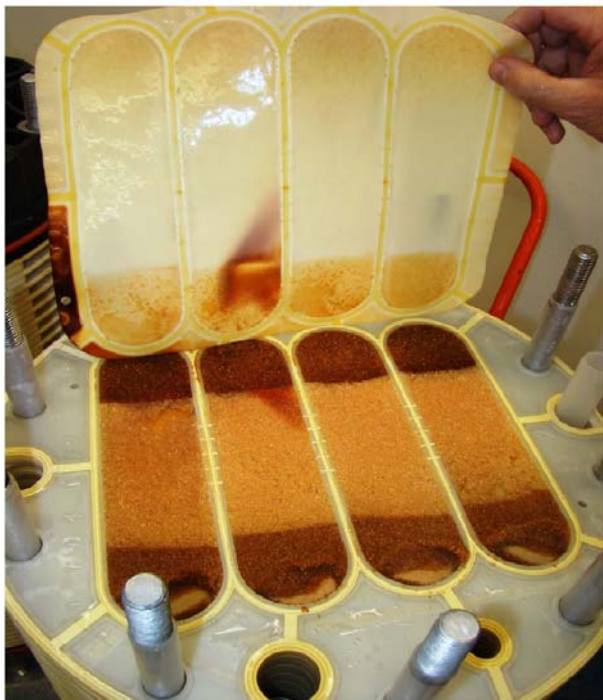
FIGURE 5–RESIN/MEMBRANE FOULING

Figure 5 illustrates fouling that was also observed on the resin and membranes. Chemical testing was inconclusive, but iron is suspected. The fouling is considered a secondary cause of the electrical resistance.

Staining and discoloration of the ion-exchange membranes and resin is typically the result of some type or degree of fouling. Samples of resin were sent for evaluation.

Results were inconclusive but showed some slight improvement in properties as a result of chemical cleanup.

Therefore fouling is considered to be a secondary cause of the high resistance and poor performance.

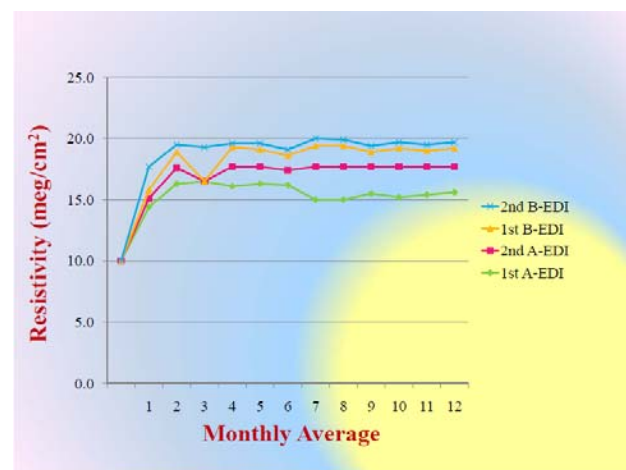
GRAPH 2–PRE & POST EDI RESISTIVITY

Despite changes in feed water quality and higher iron content, the system has produced water quality as specified. The guaranteed results presented in Table 2 have been met throughout the system operation to date. Graph 2 illustrated data collected on both the pre & post treatment EDI. The post or polishing EDI produces the guaranteed water quality even when the ROS and primary EDI was producing poor water quality due to the site operation problems.

Data provided in Graph 2 above reflects the specific conductivity of the system performance by way of real time in line instrumentations. Cation conductivity is performed by grab sample and no current data was available. The system silica is below the 10 µg/l as SiO₂, total organic carbon is below the 100 µg/l required.
